National Register of Historic Places  
Inventory—Nomination Form

historic Fairy Hill, Henry W. Carville Farm

and/or common Brampton (preferred)

Brampton, K-465

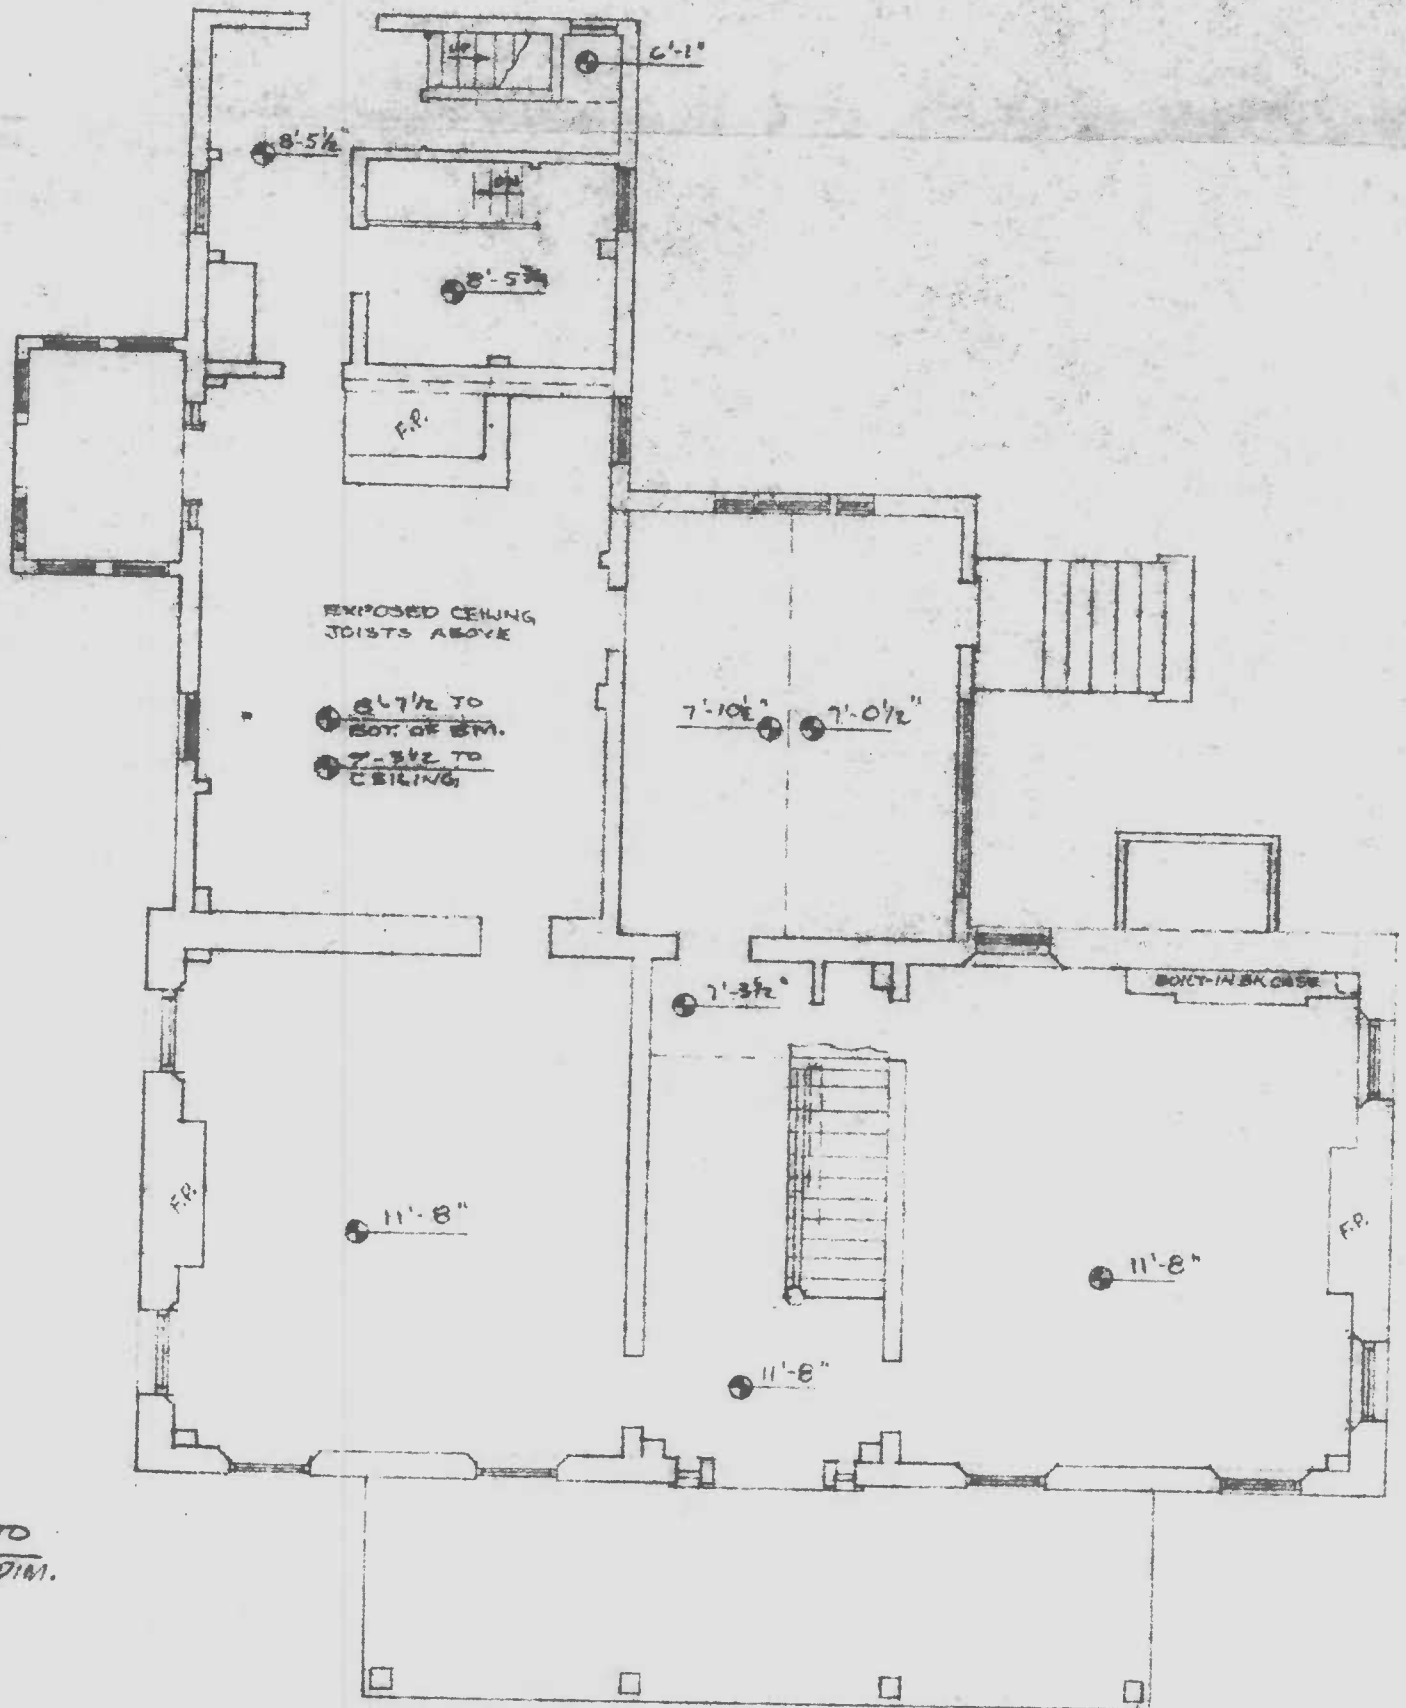
1ST. FLOOR PLAN

THIS FL TO  
 CR 16 DIM.

The interior of the main block remains essentially unaltered, retaining almost all its original plan, finishes, and ornament. The building exhibits a center-hall plan, with one room on either side. The principal stair is of the open-string type, with elaborate scrolled stair brackets, and rises in three curving flights from the entrance hallway. A heavy turned walnut newel post with an octagonal base and carved acanthus and rope motifs anchors the stair; its general shape is echoed by the turned walnut balusters, two per step, which support the heavy walnut handrail.

1. Plan type: Central hall, one room each side, with rear ell.
2. Major stair: Open-string, with 2 turned walnut balusters per tread. Massive turned and carved newel post with octagonal base, acanthus and rope-type carving, and amity button. Walnut rail is continuous for  $3\frac{1}{2}$  stories, where the stair is then enclosed for the second half-flight to the attic. Last half flight is open but narrower than lower stairs. Dog-leg type, with landing and reverse of stair direction between each floor. The open stair well between rails is about 24". There are simple carved step brackets; treads are yellow pine. On the 1st floor there is a secondary entry to the parlor under the stair, and a small closet.

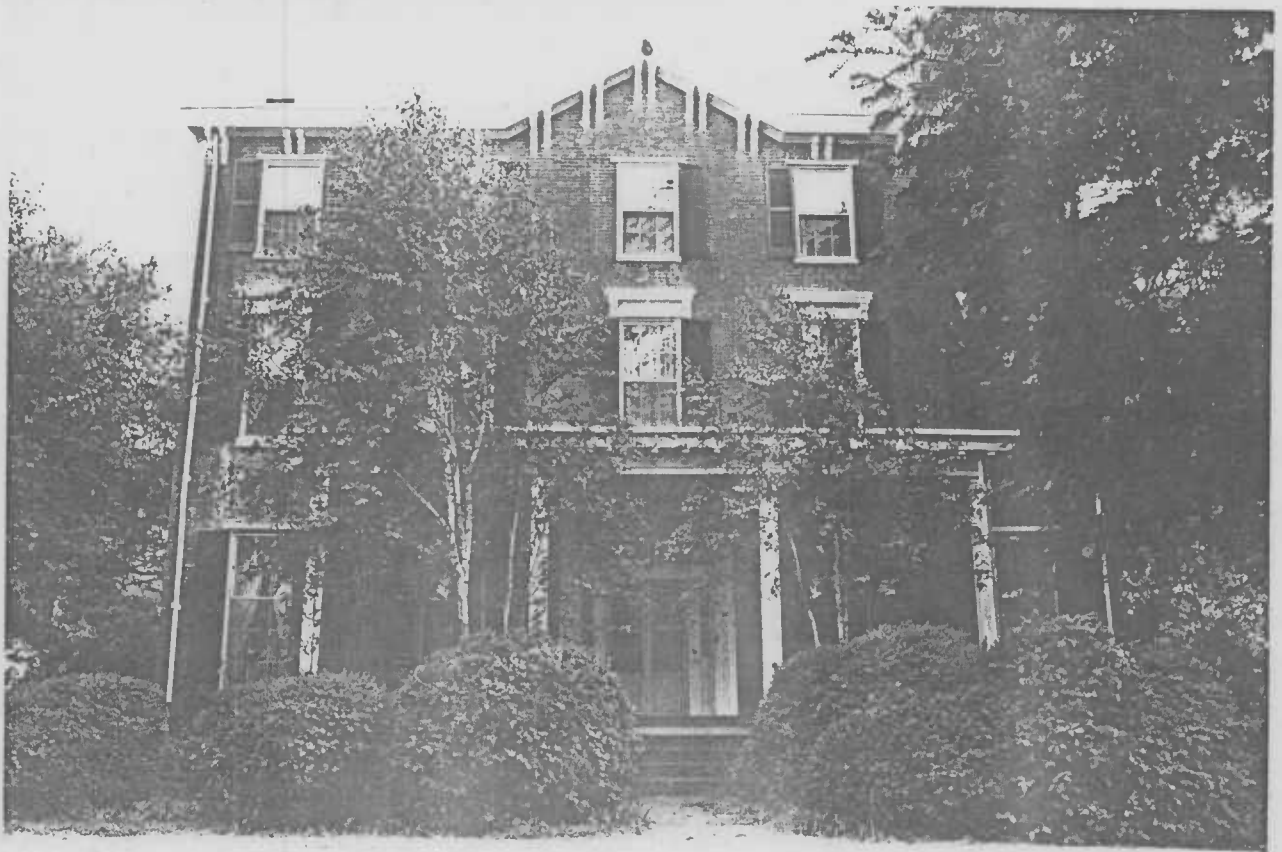
BRAMPTON (K-465)

View to South

Brampton is a large ca. 1860 transitional Greek Revival/Italianate-influenced dwelling located on the south side of Maryland Route 20 near Chestertown in Kent County, Maryland. The main block of the house, which faces north, is of brick construction, three stories high, five bays wide and two bays deep. The entrance is located in the central bay of the north facade, and consists of double doors, each with two raised and molded panels, and a 7-light transom and 4-pane sidelights in a crossetted surround. Two floor-to-ceiling 6/9 windows flank the entrance on either side. On the second story, five 6/6 windows with bold bracketed cornices are aligned above the first-floor openings. (Evidence suggests that similar cornices once graced the first-story windows.) On the third floor, slightly lower 6/6 sash appear above the second-story windows. Louvered shutters on all levels are probably replacements. The building has a shallow-pitched gable roof, clad in standing-seam metal and detailed with a bracketed cornice and a shallow cross-gable above the central bay. A one-story porch, with chamfered posts and bracketed cornice, spans the three central bays; this porch may represent a late 19th century addition.
